2.16.1 APPENDIX - HISTORIC ARTWORKS

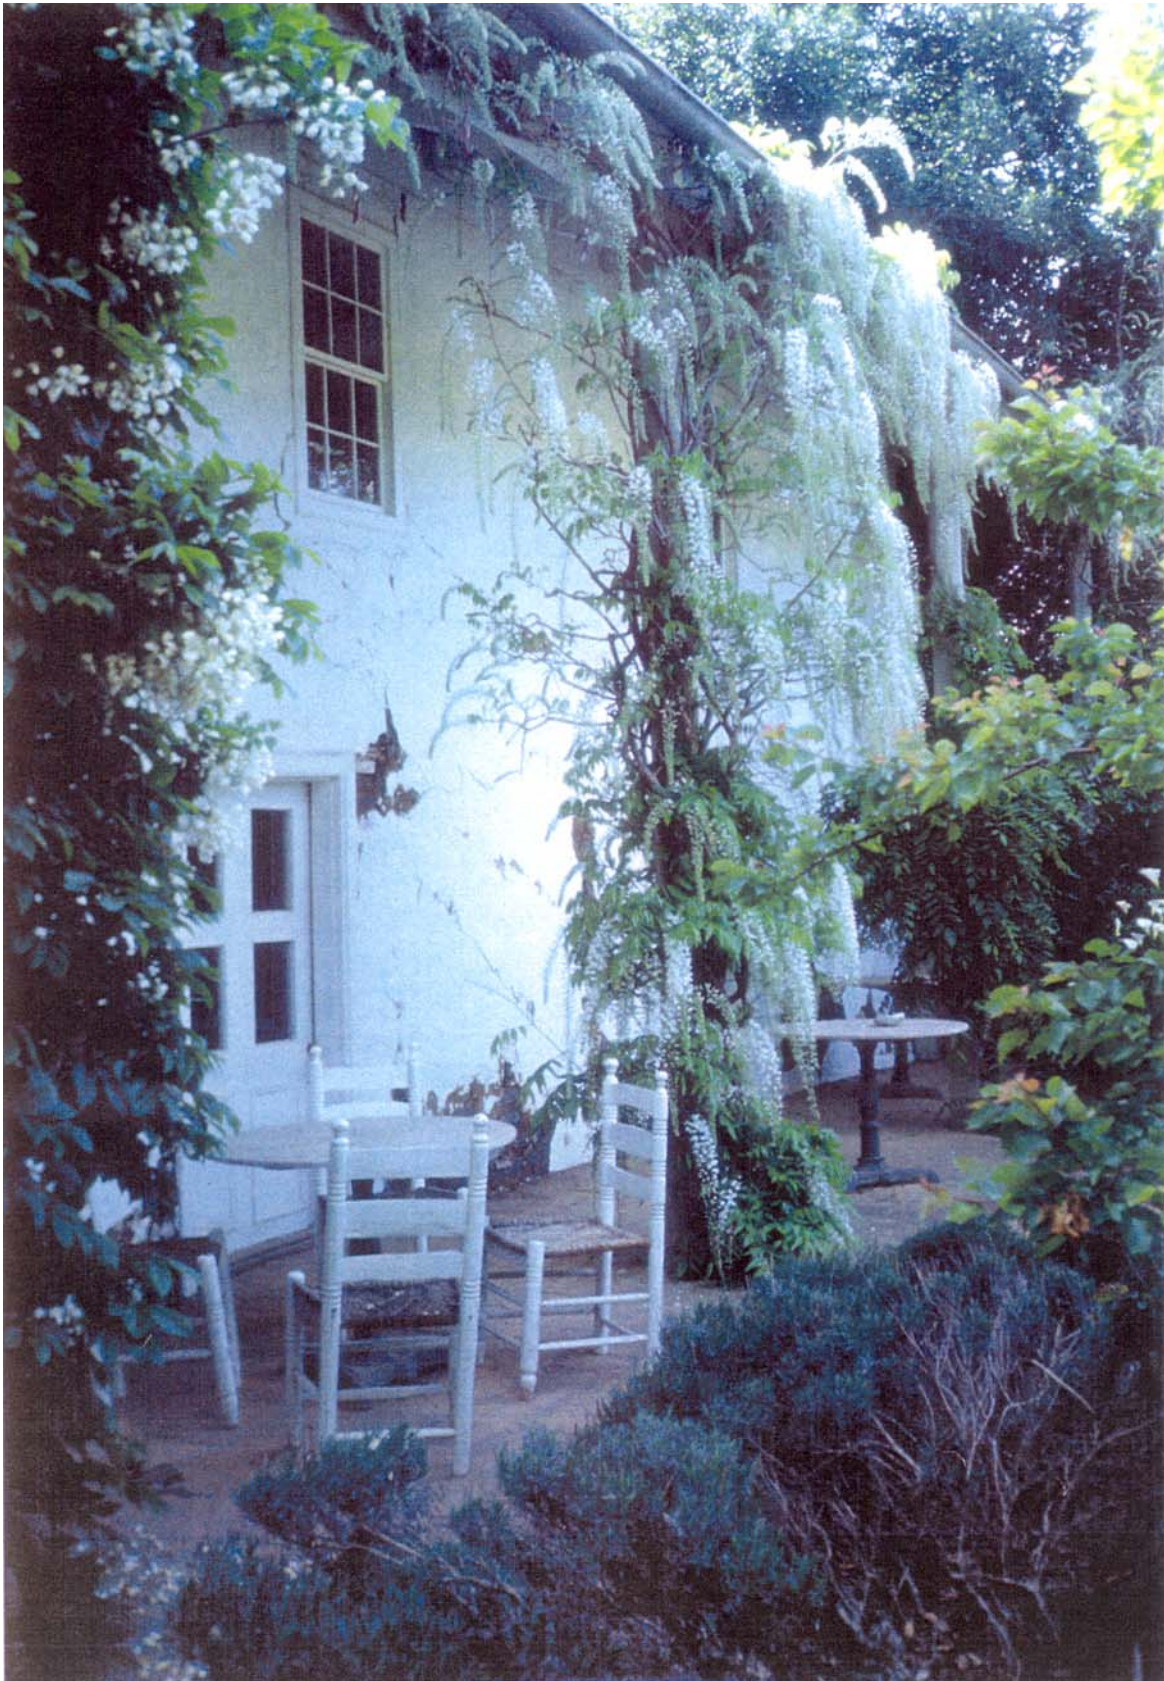
HP24 Rancho San Andres Castro Adobe with wisteria. Note doors, window sash and trim painted white. Roof support posts reintroduced matching those of Hansens in 1880s at the front. 1990 Edna E. Kimbro photographer.

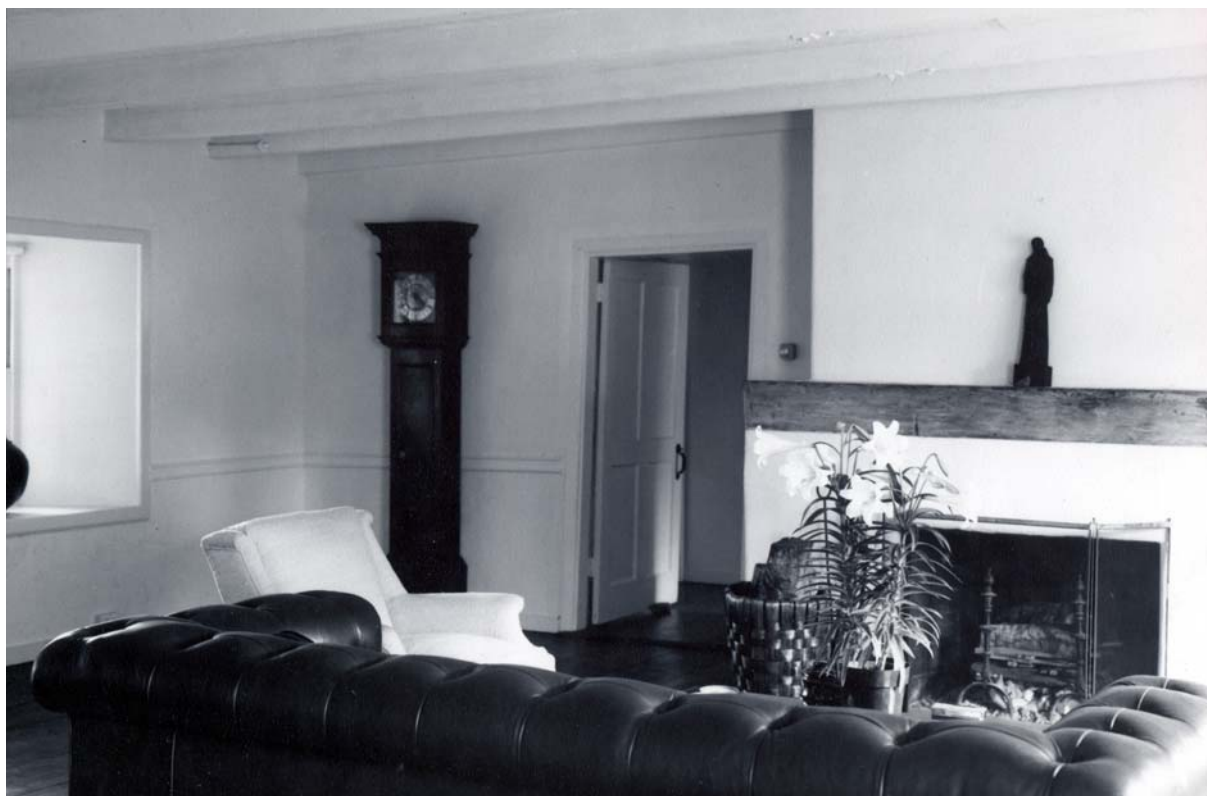
HP25 Rancho San Andres Castro Adobe interior Room 103 looking south. 1971 Bangs photograph.

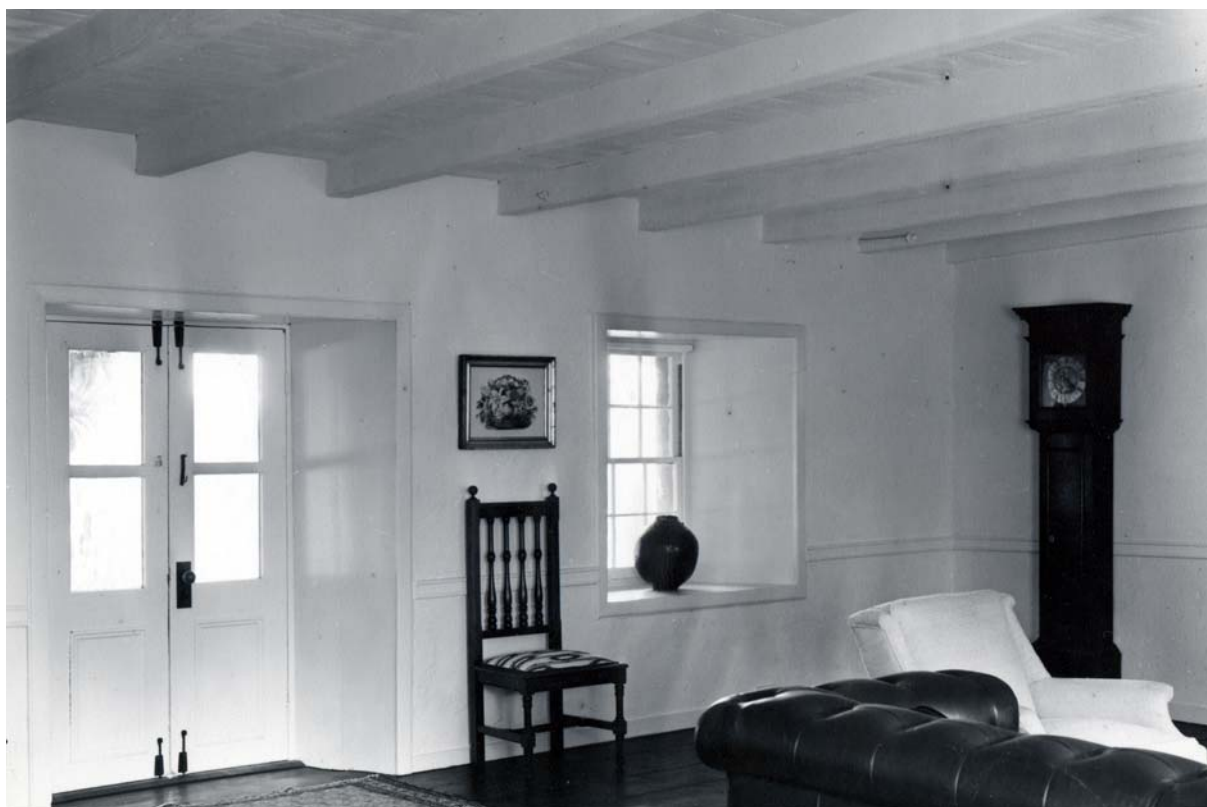
HP26 Rancho San Andres Castro Adobe interior Room 103. 1971 Bangs photograph.

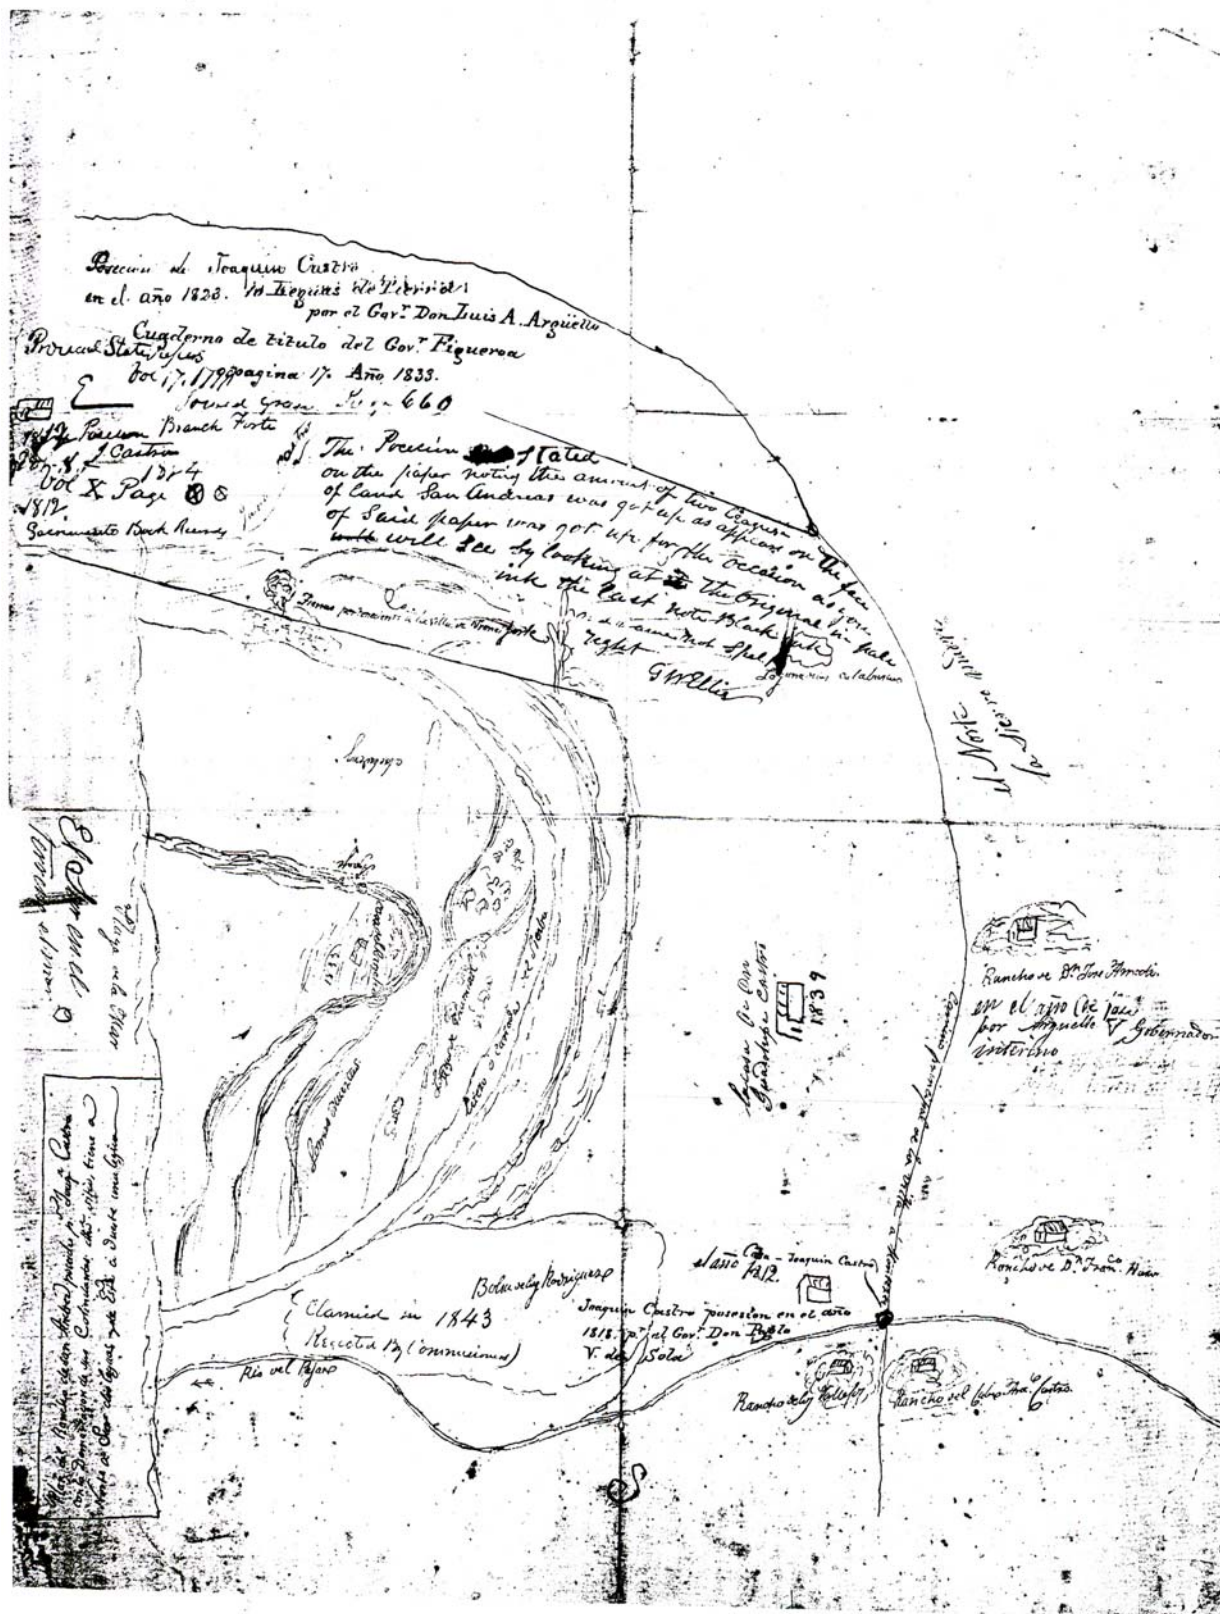
2.16.3.4 Appendix - Map –Survey of Rancho San Andres showing Jose Castro's house and the embarcadero. Castro Adobe Collection.
